PB00-910401
NTSB/AAR-00/01
DCA97MA058

AIRCRAFT ACCIDENT REPORT

CONTROLLED FLIGHT INTO TERRAIN
KOREAN AIR FLIGHT 801
BOEING 747-300, HL7468
NIMITZ HILL, GUAM
AUGUST 6, 1997

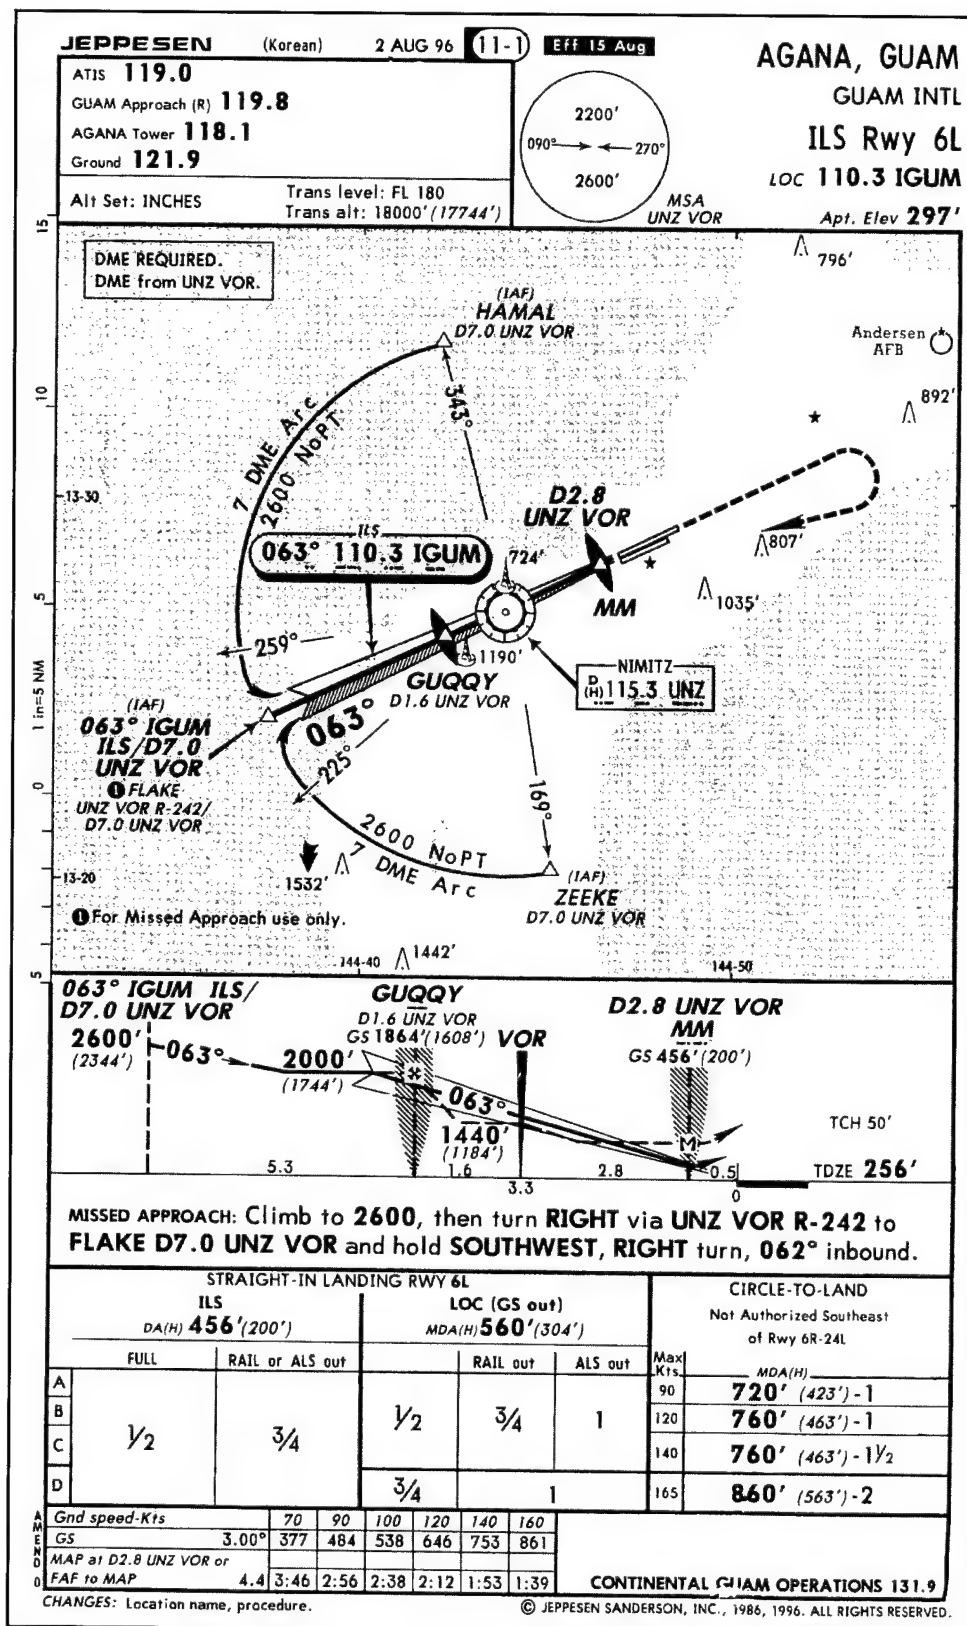
Figure 1. Instrument approach chart for the Guam International Airport runway 6L ILS procedure.

Figure 1 shows the instrument approach chart for the Guam runway 6L ILS procedure that was in effect at the time of the accident. Figures 2 and 3 show FDR information for the last 5 ½ minutes of flight, along with CVR comments and sounds and air traffic control (ATC) data.

The instrument approach charts for Guam International Airport in effect at the time of the accident were issued on August 2, 1996 (with an effective date of August 15, 1996). Changes incorporated in the August 2, 1996, 11-1, ILS runway 6L approach chart (shown in figure 1) included the location names, crossing altitudes, and the missed approach procedure. Table 2 details the specific differences between the January and August 1996 instrument approach charts.

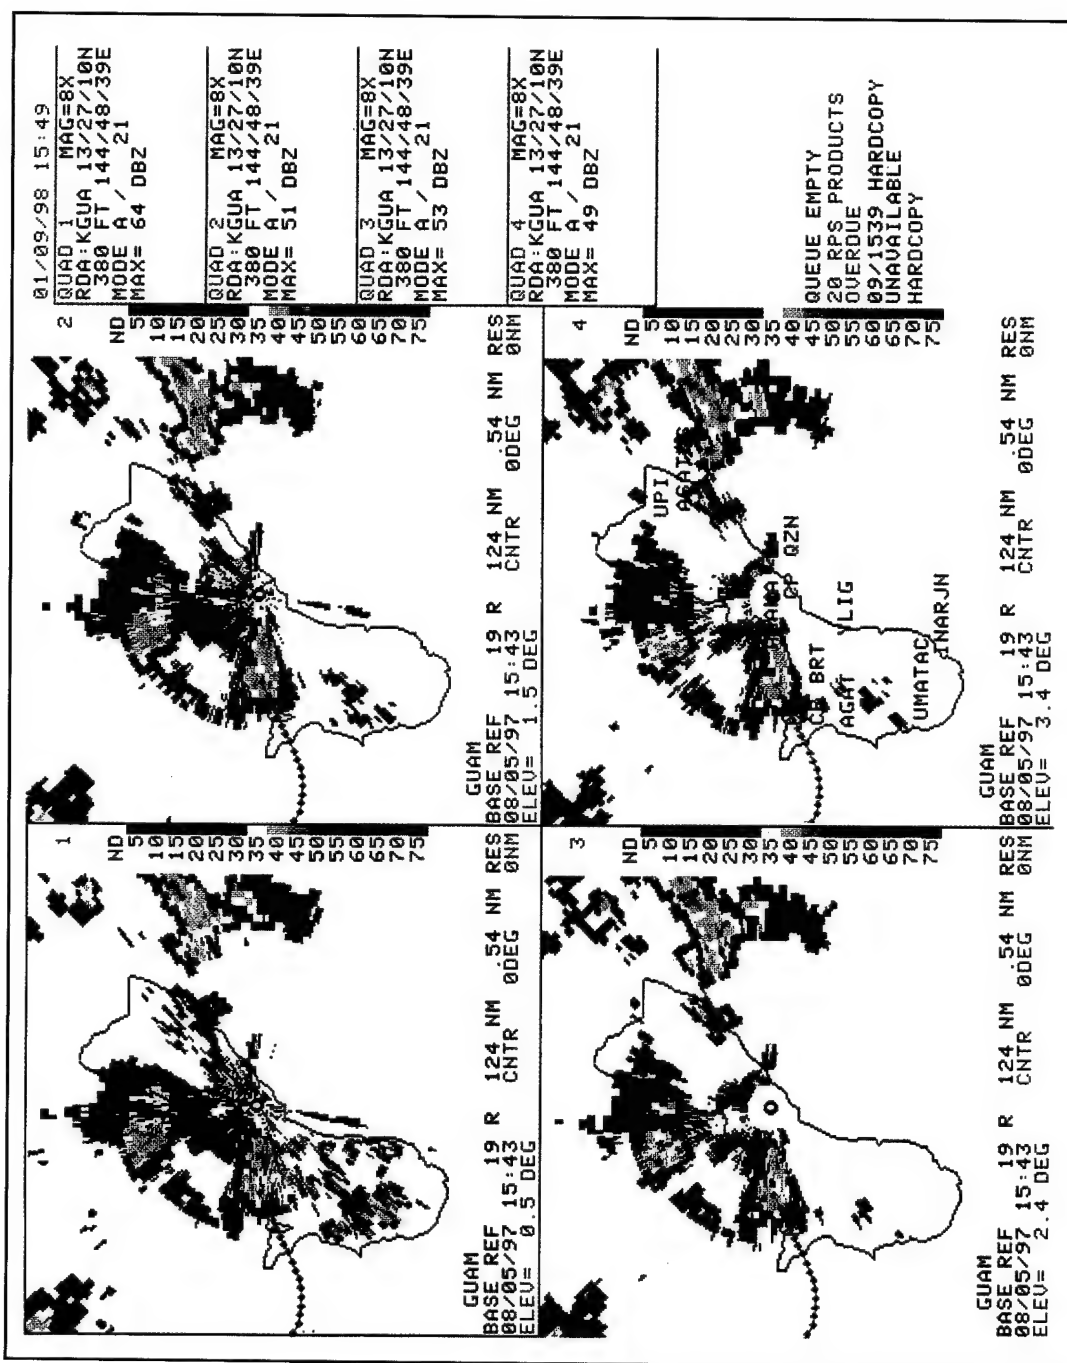
Figure 6. WSR-88D four-panel base reflectivity product for Guam.

The radar antenna of the Guam Weather Surveillance Radar-1988, Doppler (WSR-88D) was located about 5 nm east of the accident site. Data recorded about 0143 on August 6 (1543 UTC time on August 5, 1997) indicated an area of precipitation over higher terrain about 4 nm southwest of the airport, including Nimitz Hill. The precipitation was oriented east to west, about 7 to 8 nm long and 3 to 4 nm wide, and was moving toward the west. Figure 6 shows the WSR-88D four-panel base reflectivity product for 0143.

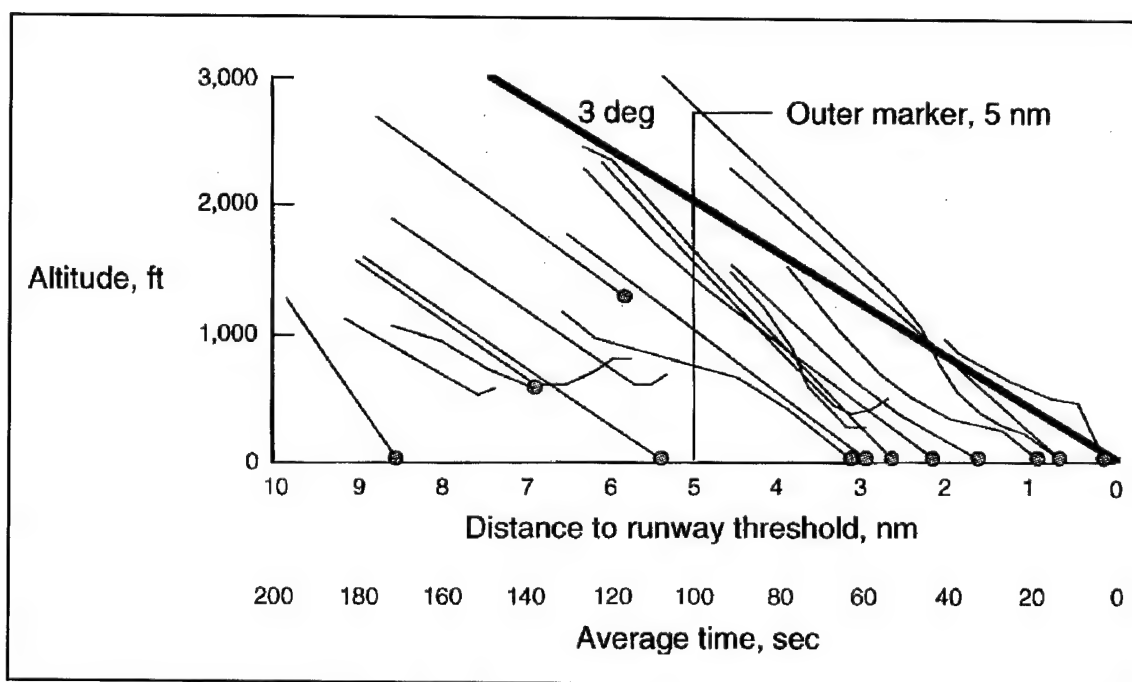
Figure 10. Vertical profile information from the 40 CFIT accidents and incidents between 1986 and 1990.

The captain stated that 70 percent of the CFIT accidents occurred on final approach and that most of these aircraft were "...in line with the runway." The captain also stated that "...many accident aircraft [were] underneath the three-degree glideslope [of a precision approach]." Figure 10 shows vertical profile information that was available from the 40 CFIT accidents and incidents that occurred between 1986 and 1990, as prepared by Boeing and provided by the FSF's CFIT Awareness Task Force.
